Multiple Sclerosis
Otago

8 Baker St Summary

OPTIONS REPORT

8 Baker Street, Dunedin

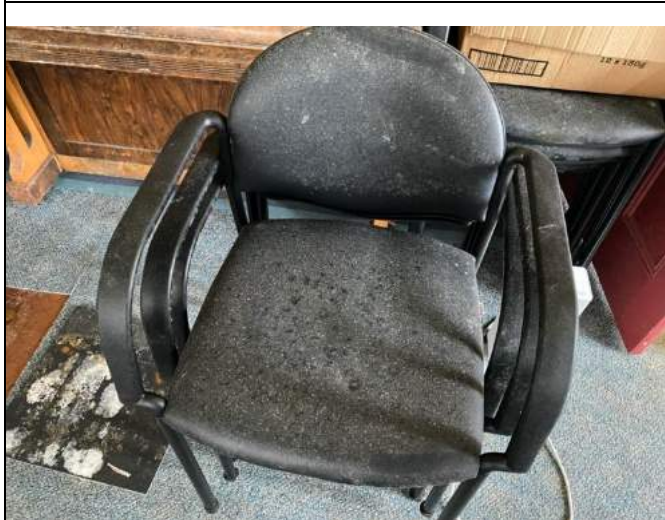
<p>Faux Leather to Function Room</p>	<p>Timber to Function Room</p>

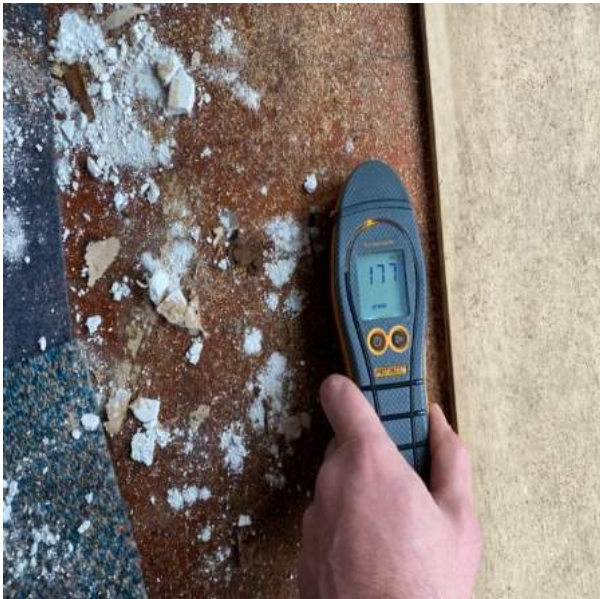
Floor to Function Room

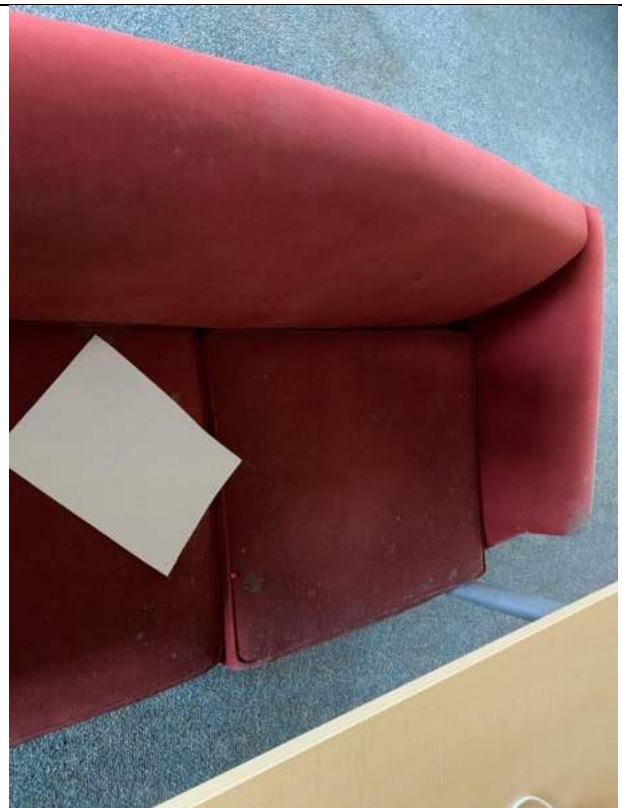
Fabric in Function Room

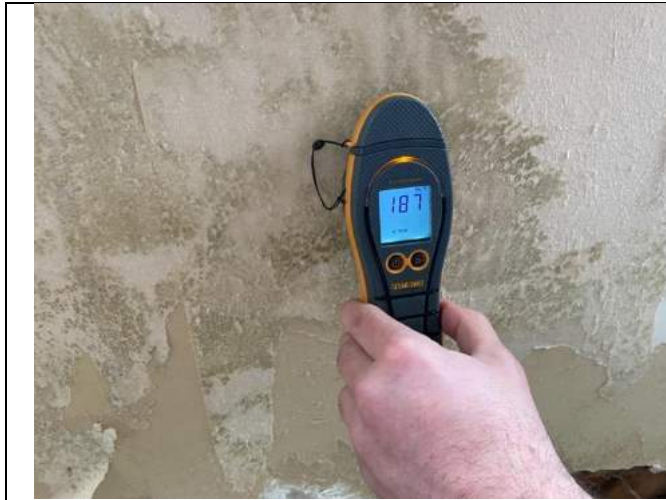
**Walls to Function
Room**

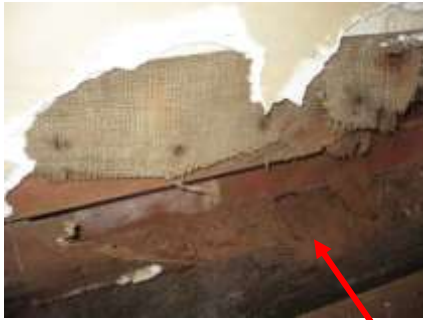
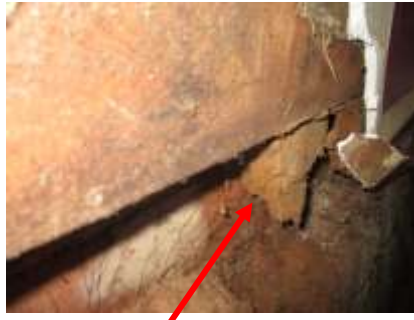
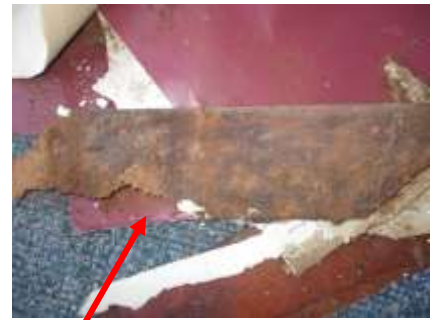
Wall under the window – just pulled to bits with my hands – timbers rotten – gib linings soft with dampness

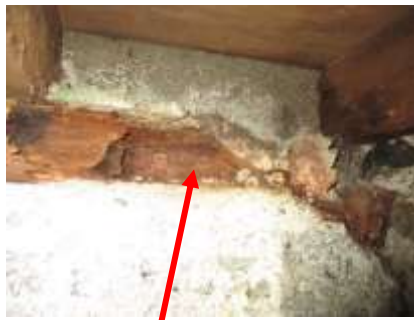
Bearer here on the foundation completely rotten – Mould

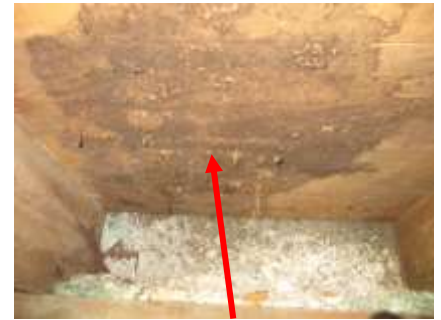
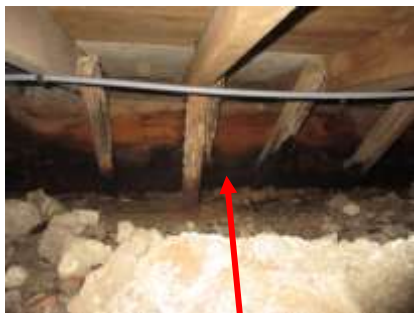
Soaking wet boxing left from the meeting room side addition

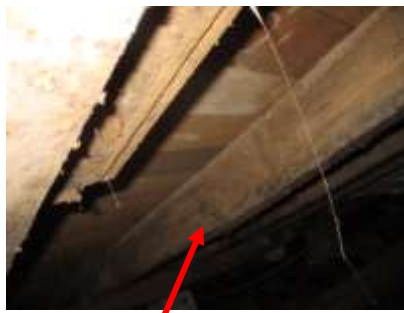
Broken joist

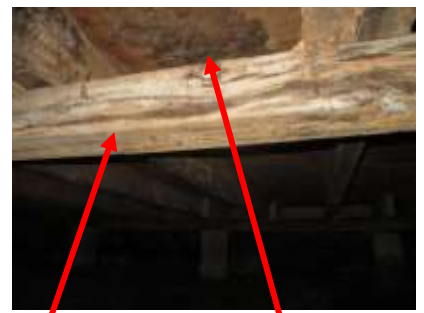
Rot in the bearer – mould on flooring

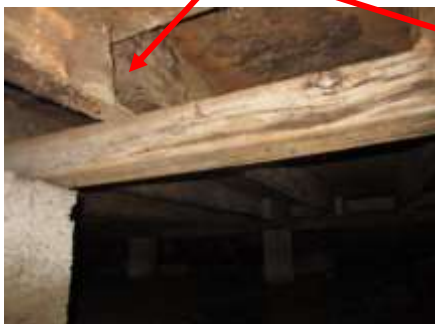
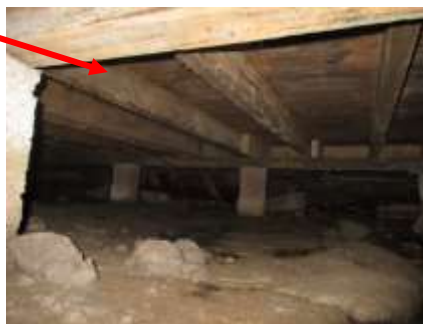
Floor joist in the store room fell off when we cut the floor

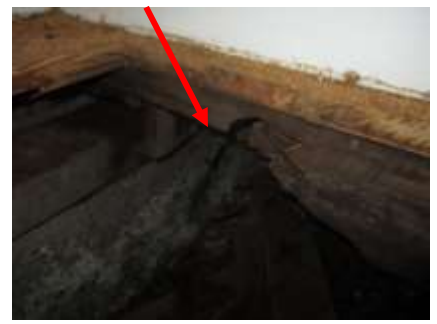
Some of the affected timbers have more borer than rot and would need to be replaced as well

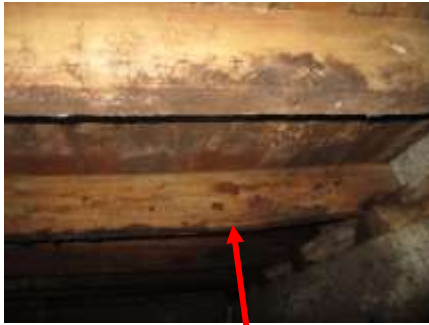
Store room joists broken and rotten

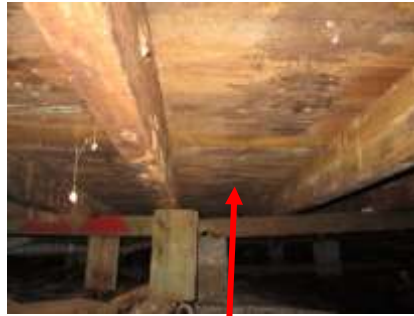
Printer room floor rotten timbers

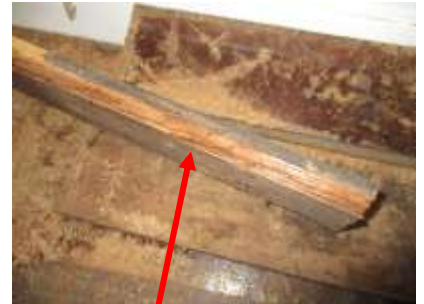
Borer ridden flooring

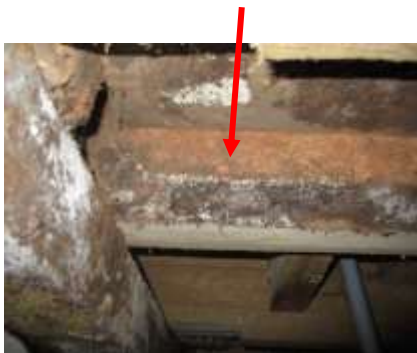
Nice and dry in the wall in the store room

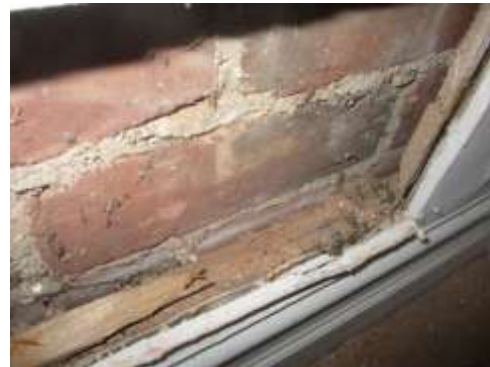
Hall floor repair finishes here
