Multiple Sclerosis
Otago

8 Baker St Summary

OPTIONS REPORT

8 Baker Street, Dunedin

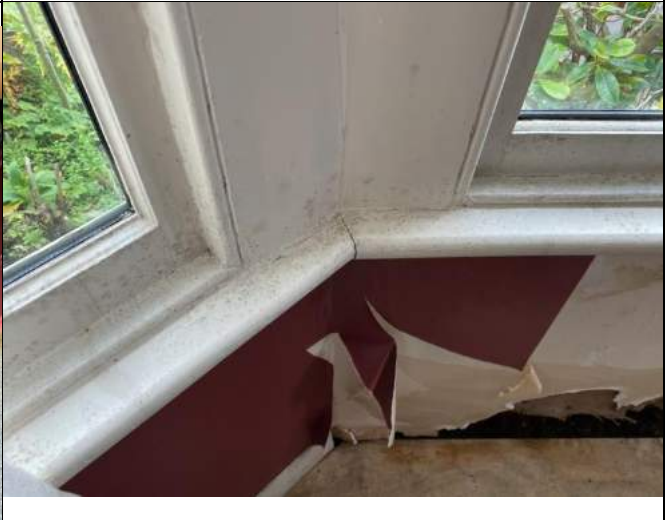
<p>Faux Leather to Function Room</p>	<p>Timber to Function Room</p>

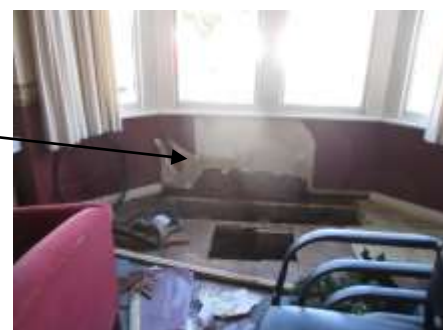
This section of the wall below the window is in really poor condition

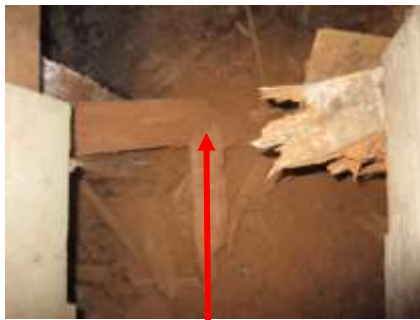
Wall under the window – just pulled to bits with my hands – timbers rotten – gib linings soft with dampness

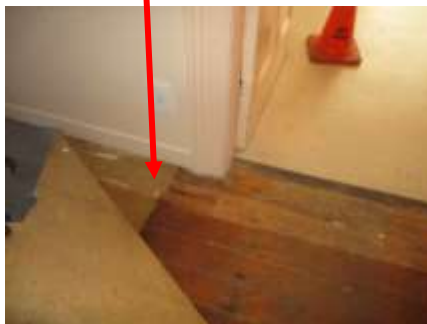
Hall floor repair finishes here

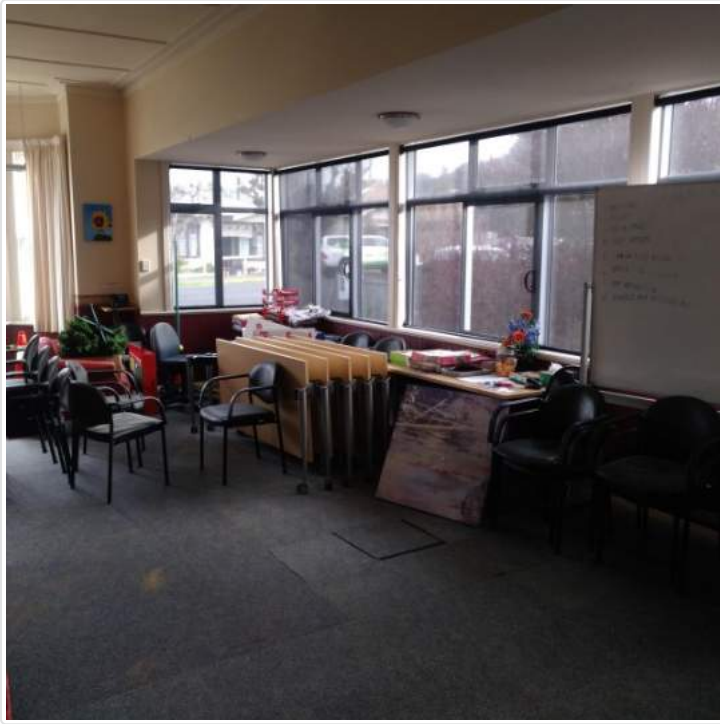
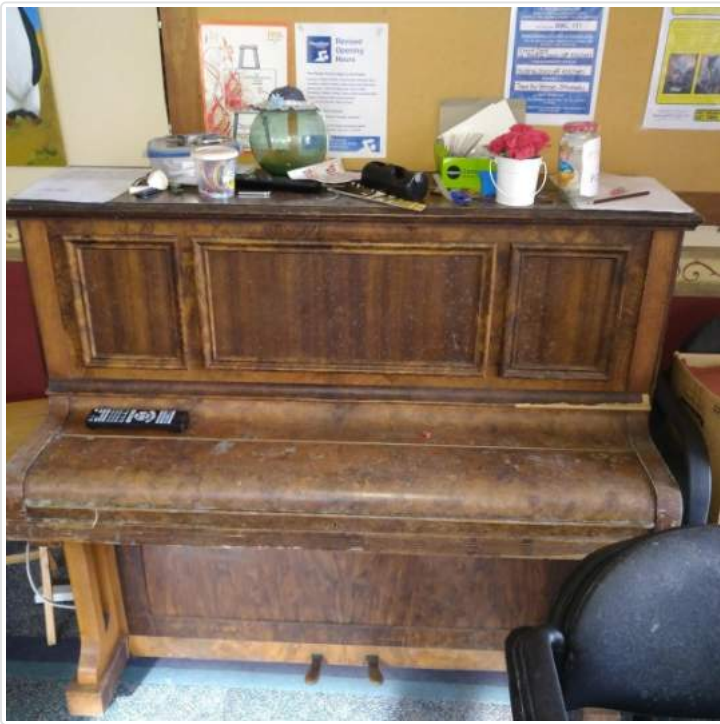
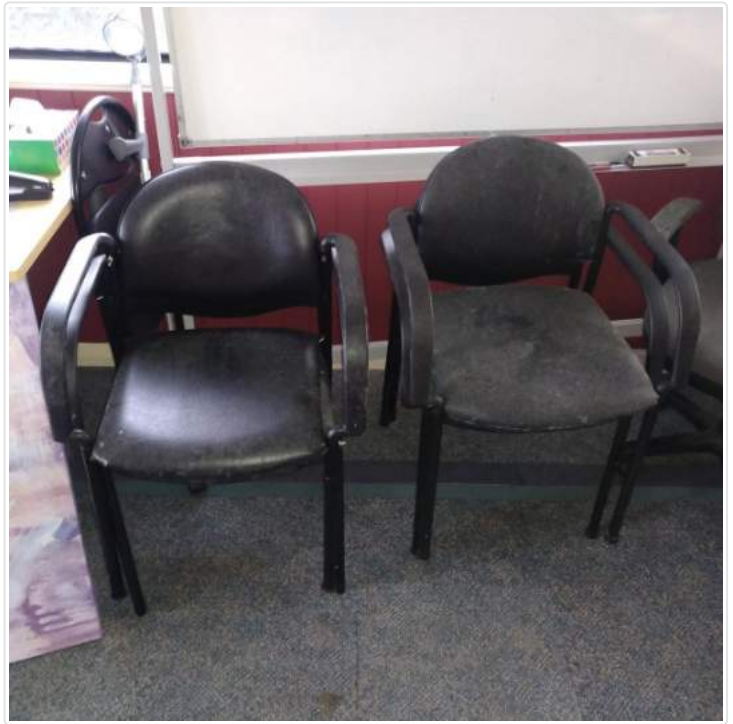
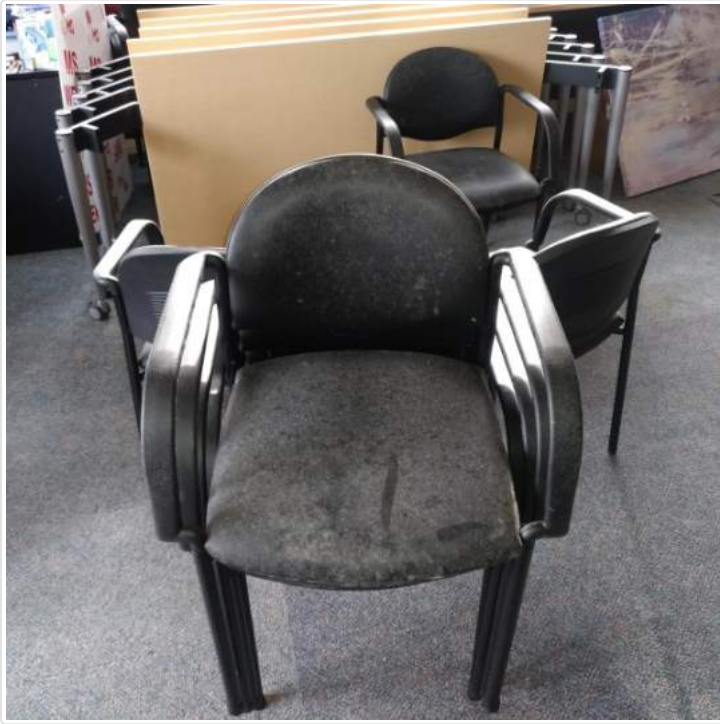
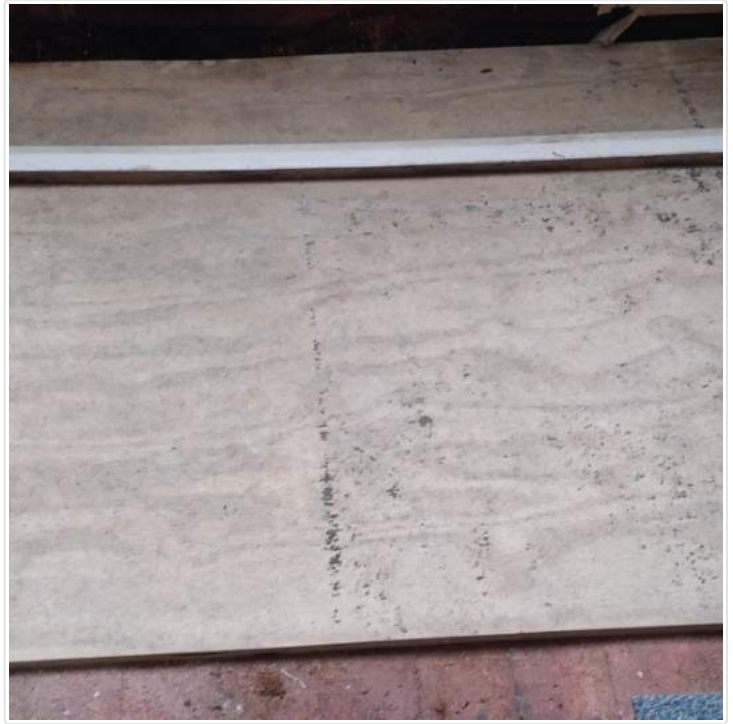
Upon inspection of the property and based on the Consultex report there is an extensive amount of fungal growth in the sub floor of the function room. The mould spores and micro toxins appear to have spread throughout the front part of the property with some small traces identified in the back offices.

Initially to prevent the contents within the property deteriorating to the point where it needs to be disposed of, we feel that the non porous items need to be removed and decontaminated through a positive air chamber then stored in the garage. The porous items such as the carpets, couches, curtains and chairs should be disposed of. The recommendations are in line with the Australian Mould Guideline 2010 and IICRC S520: Standard and reference guide for professional mould remediation. Please see recommendations below:
